UNDERWATER BRIDGE INSPECTION REPORT

STRUCTURE NO. 09513

THE ST. LOUIS RIVER

PREPARED FOR THE
MINNESOTA DEPARTMENT OF TRANSPORTATION
BY
COLLINS ENGINEERS, INC.
JOB NO. 3512 (CEI 70)

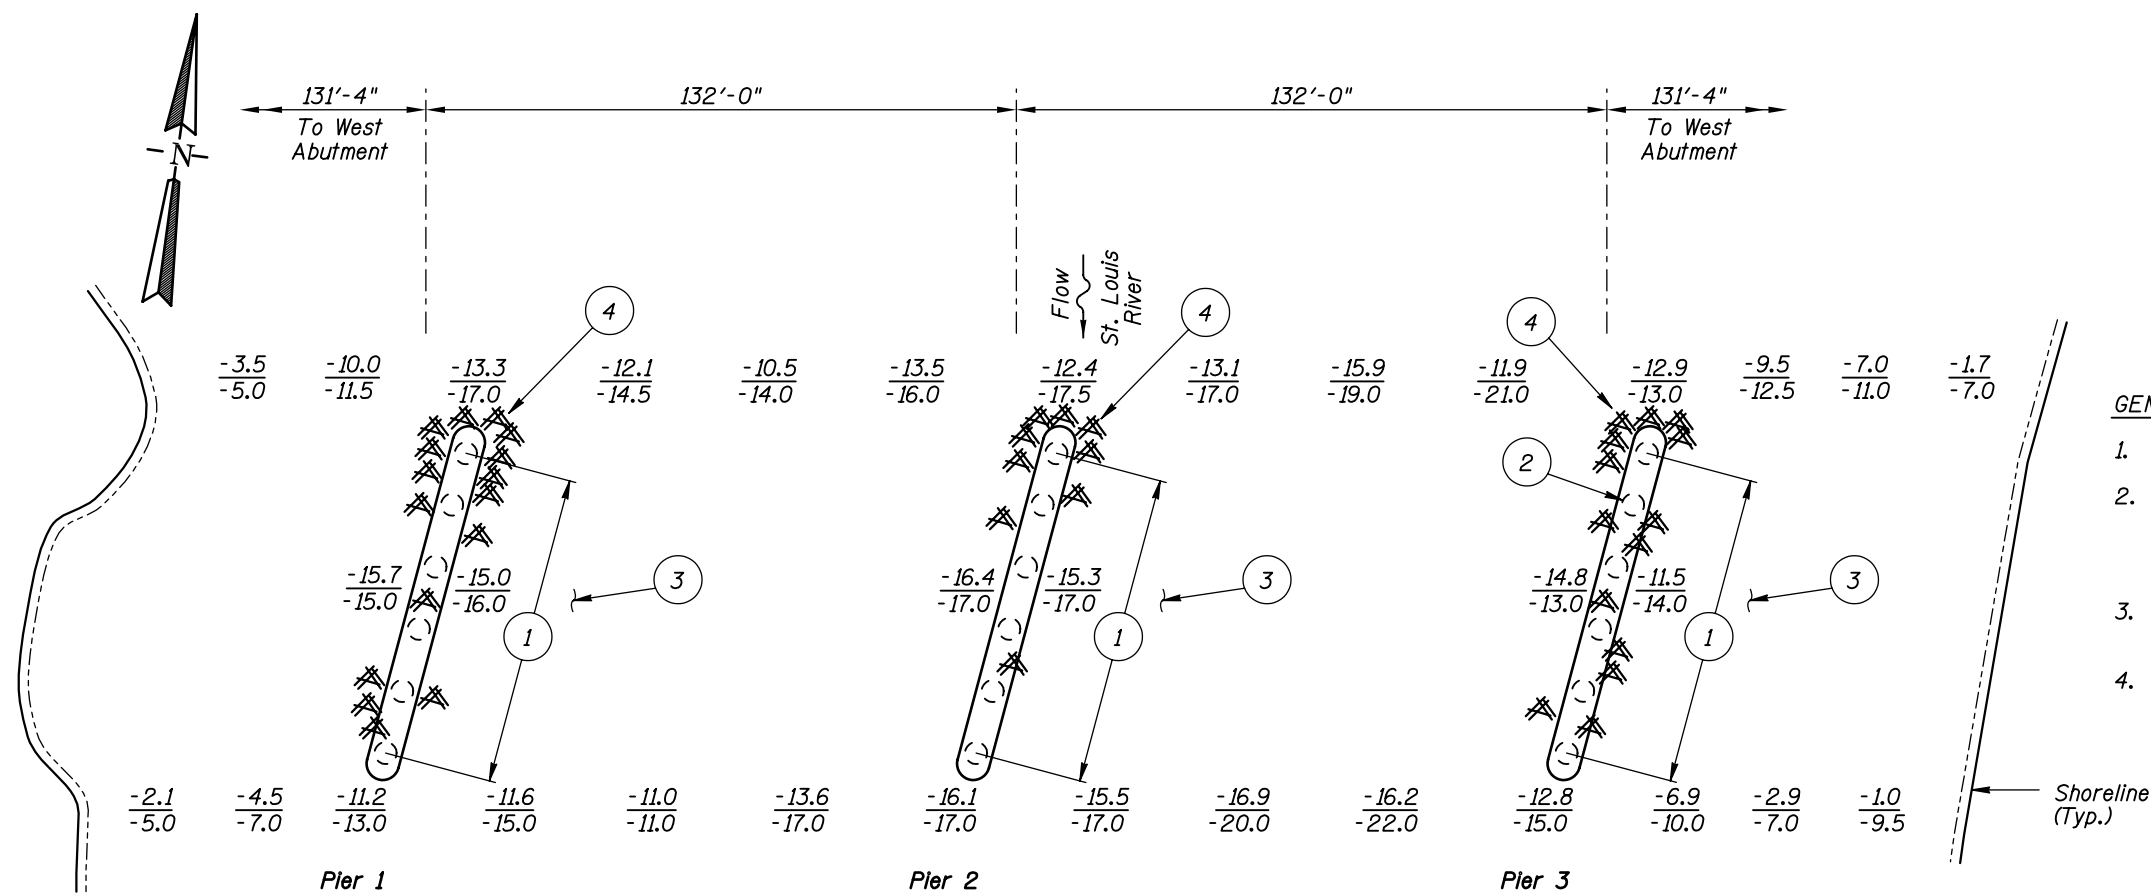
INSPECTION AND SOUNDING PLAN

- The steel pipe piles exhibited minor coating failure ranging from 10 to 25 percent with up to 1/2-inch-diameter nodular corrosion from the waterline to 8 feet below, and 25 to 50 percent coating failure with up to 1/2-inch-diameter nodular corrosion from 8 feet below the waterline to the channel bottom.
- A steel collar extending from the channel bottom to 8 feet above the channel bottom with 100 percent nodular corrosion and up to 1/16-inch-deep section loss.
- The channel bottom consisted of sand and gravel with 8 inches of probe rod penetration and occasional cobbles and riprap.
- A moderate accumulation of 1-foot-diameter and smaller timber debris, ranging from 3 feet high off the channel bottom at the upstream end of the piers to 1 foot high throughout the pier, was observed on the channel bottom.

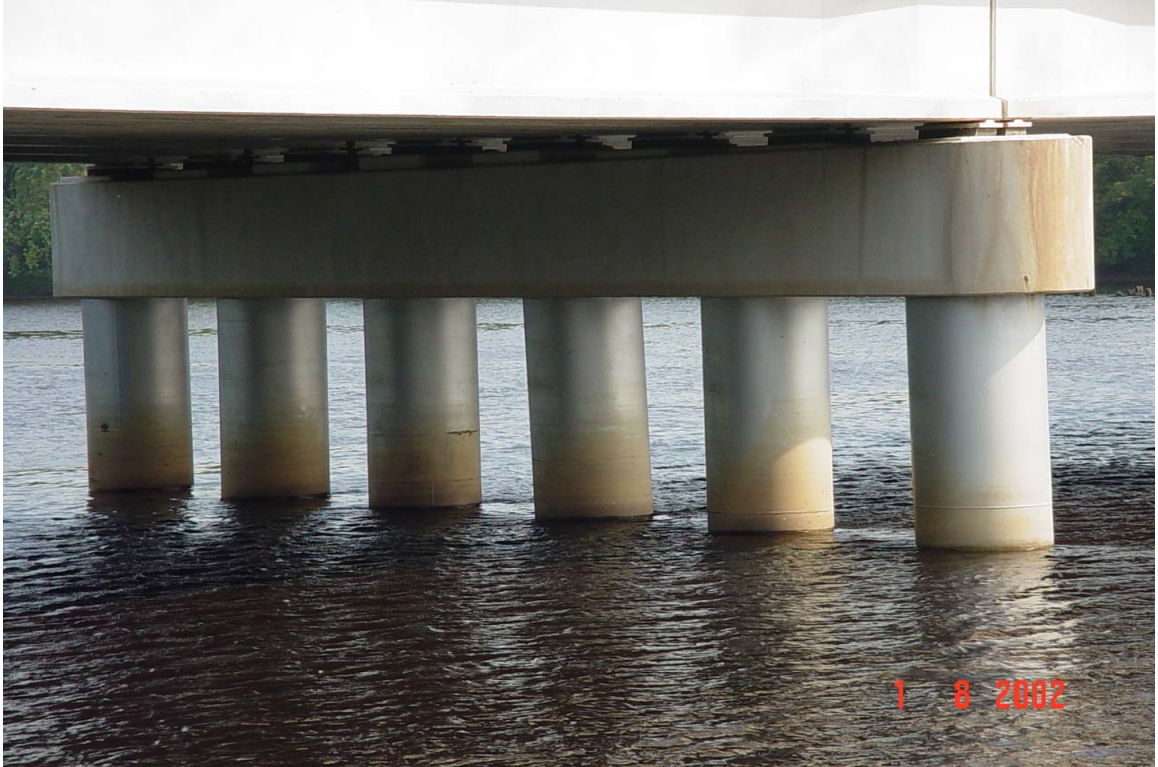
Photograph 1. View of Pier 1, Looking Northeast.

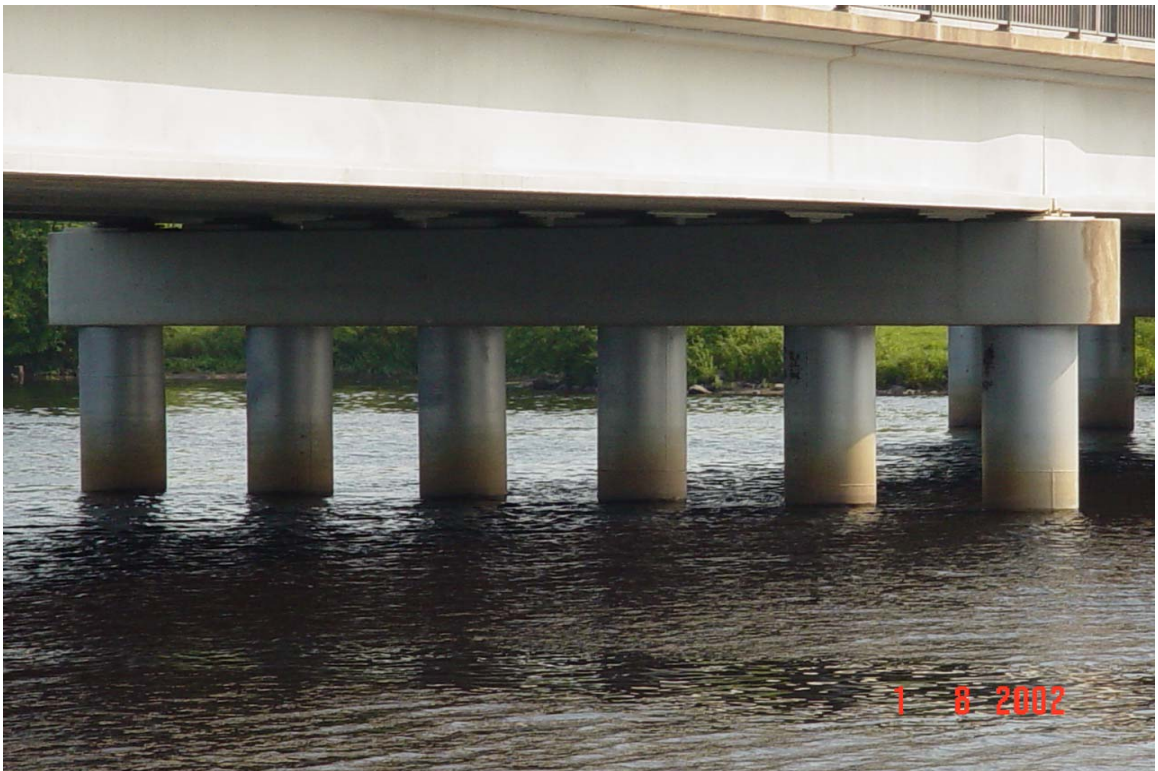
Photograph 2. View of Pier 2, Looking Northeast.

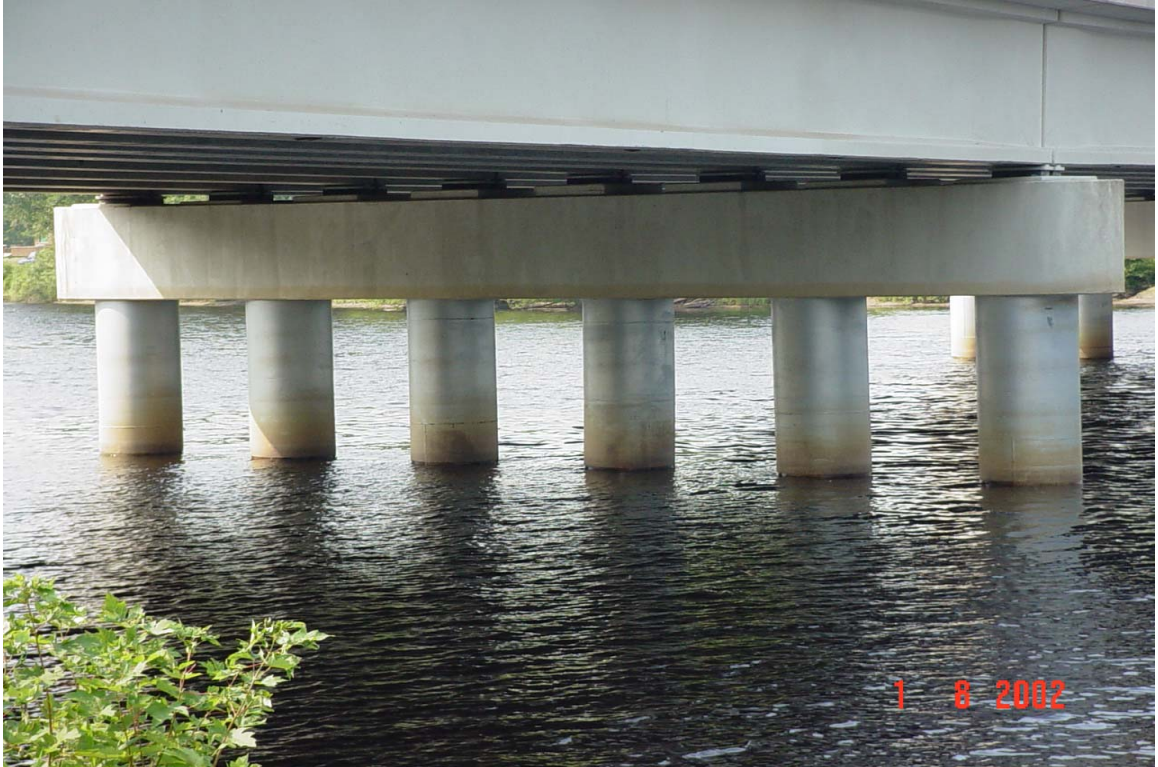
- (B) A steel collar extending from the channel bottom to 8 feet above the channel bottom was observed on the second pile from the upstream end of Pier 3 and it exhibited 100 percent nodular corrosion with up to 1/16 inch section loss.

Photograph 3. View of Pier 3, Looking West.

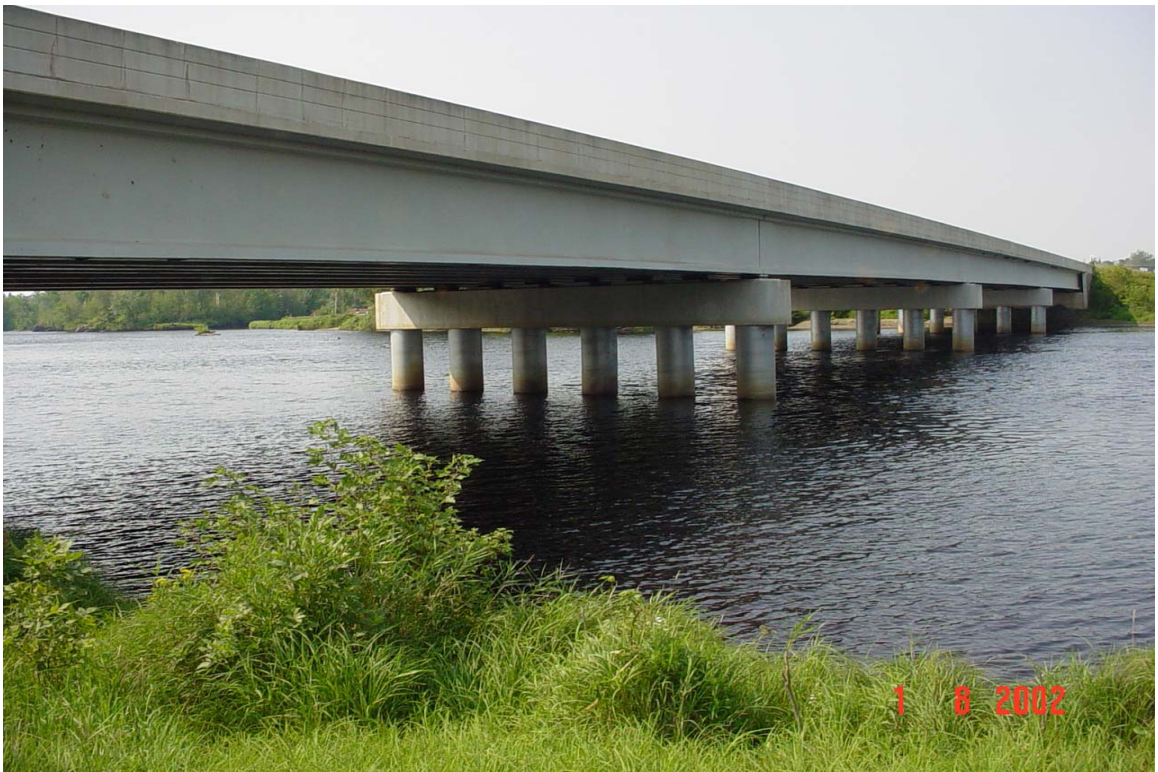
Photograph 4. Overall View of the Structure, Looking Southwest.
